# ***Evaluation Report for the Amphenol-Bendix 453 Miniature Circular Connector with Mil-T-29504 Optical Termini in a Vibration Environment***

**Jeannette Plante**

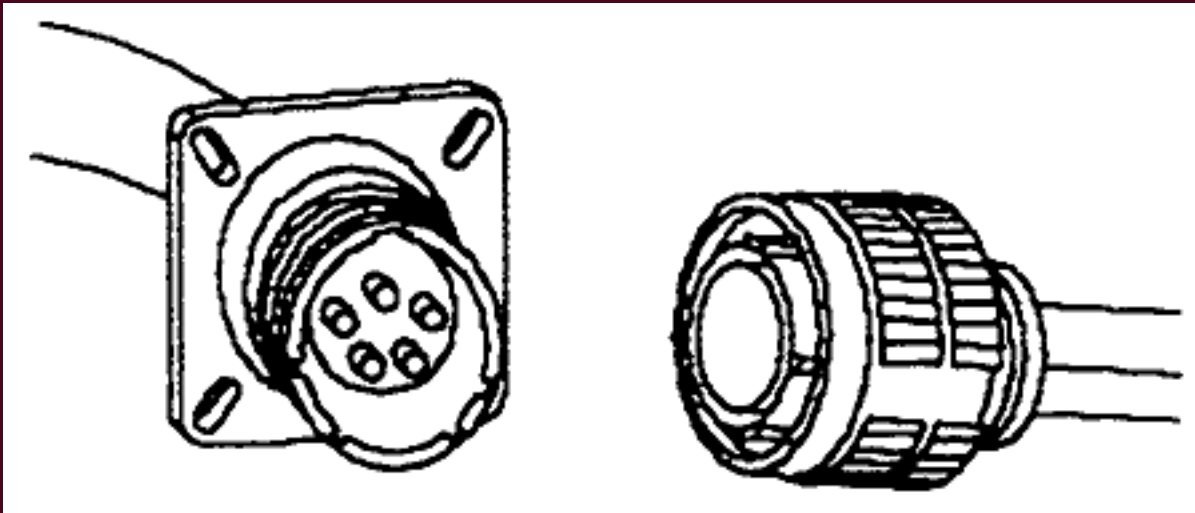
The "453" - M29504 connection system can be used to replace multiple, individual, MIL-C-83522, SMA type, single fiber connectors. This approach should improve reliability and performance by decreasing the number of individually mating connectors and by introducing a physically contacting (PC) mate at the fiber ends. SMA connectors allow an air gap between the fiber ends which limits the performance to the air gap loss (typically 0.34 dB to 2.0 dB depending on the width of separation between the fiber ends). The M29504 termini are designed and polished to eliminate the air gap between the fiber ends.

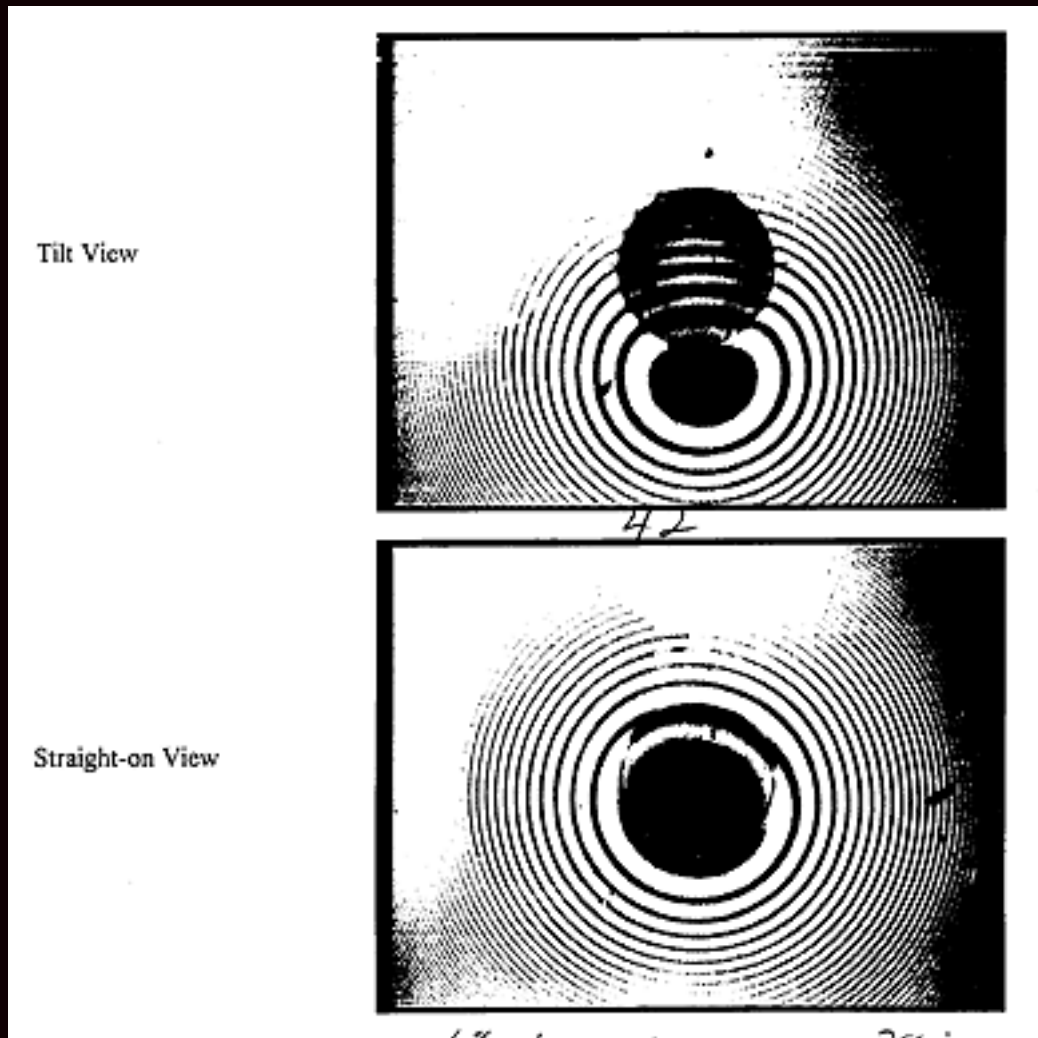
## [Table of Contents](#)

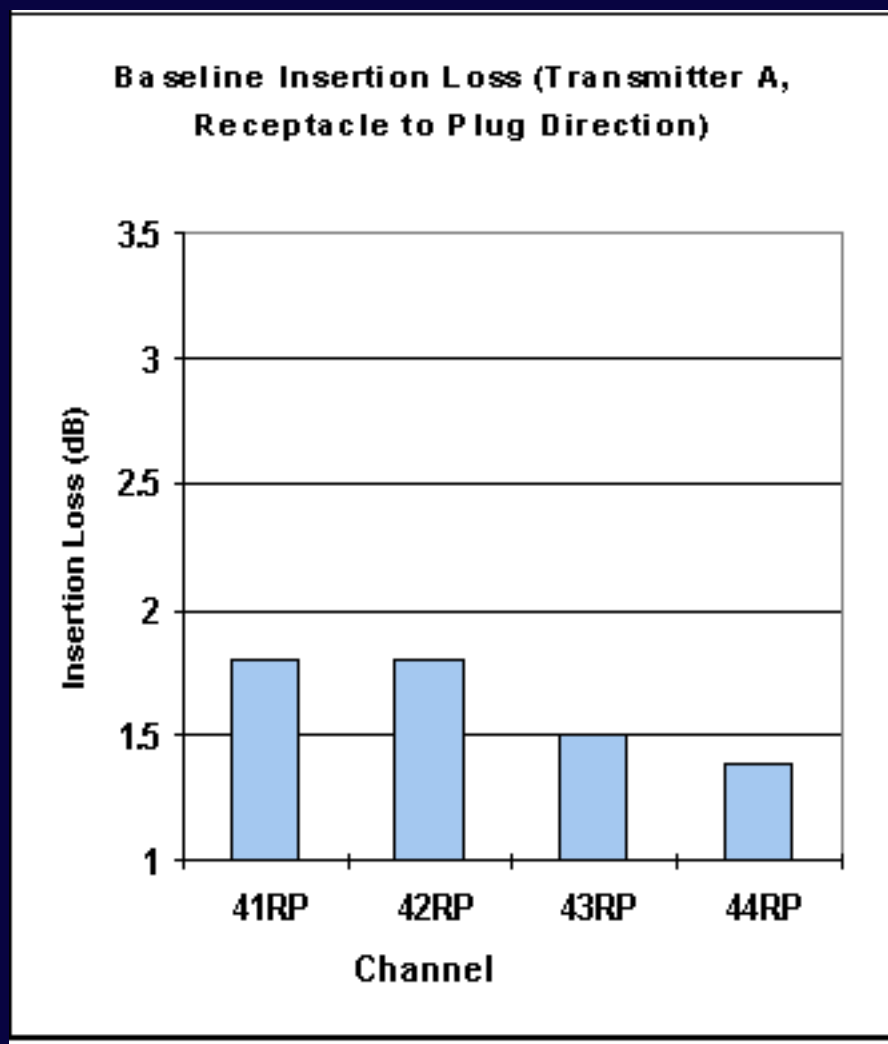
The term throughput is used when no launch cable was used in the measurement (units in dBm), as opposed to insertion loss which incorporates a launch cable and is recorded in dB. Some of the lack of repeatability of the data was due to the single fiber SMA connectors used on each of the free ends of the evaluation cable channels. The SMA connector design is non-keyed and incorporates a threaded coupling nut that can cause variation in the mate condition, in air gap width and termini radial alignment, each time the connector is mated.

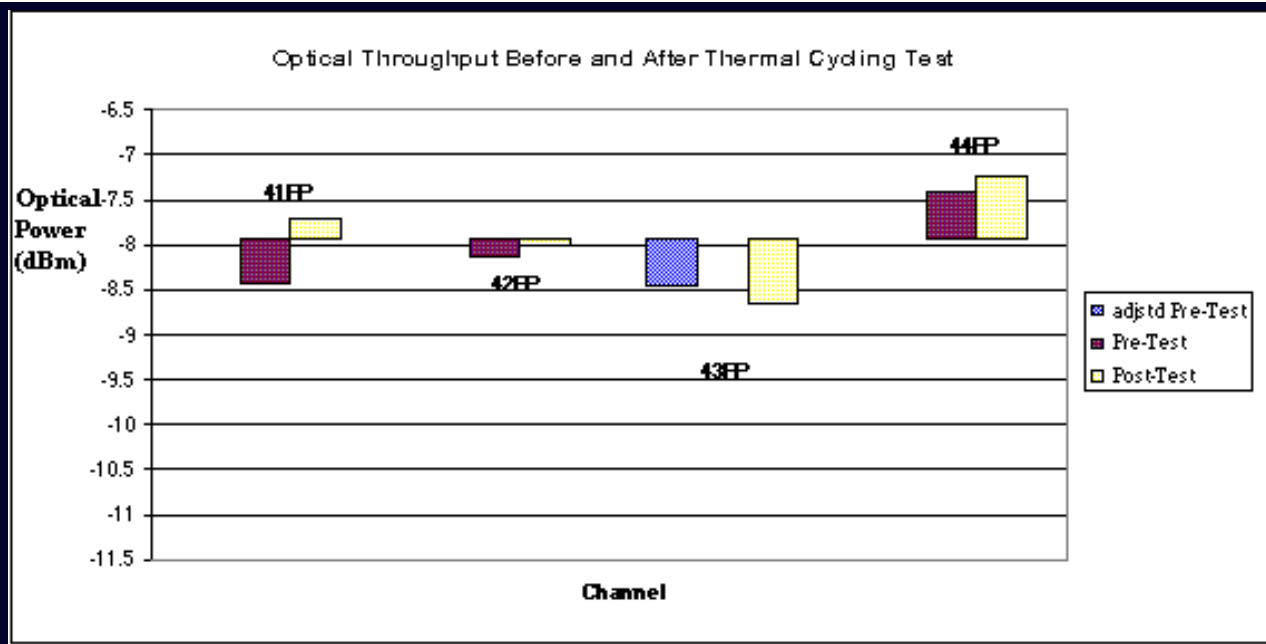
Table 4. Results of Post Thermal Cycling Visual Examination

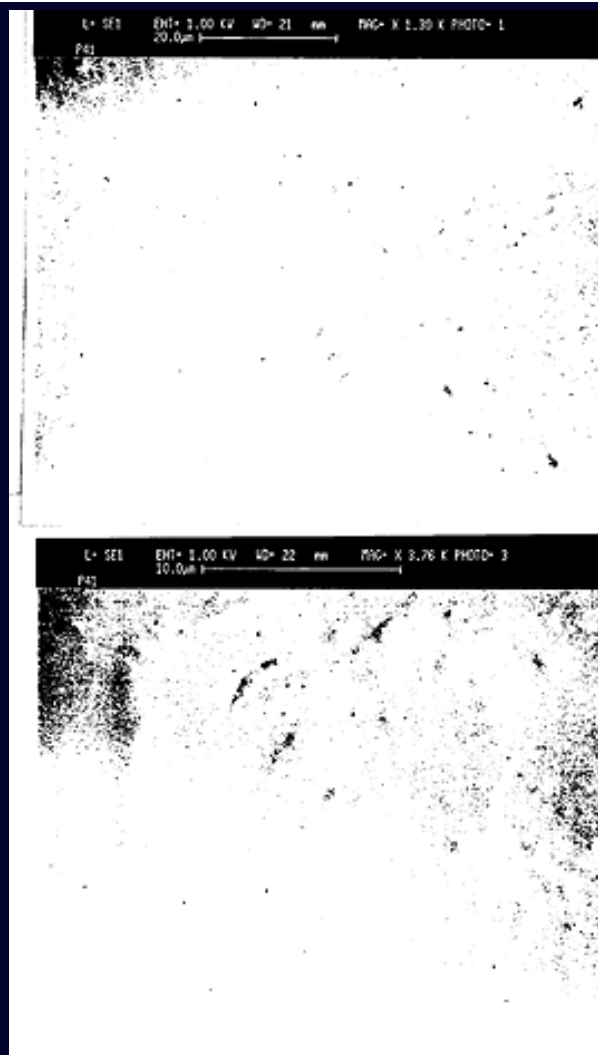
### Roughness Not Seen in Optical Microscope Photograph

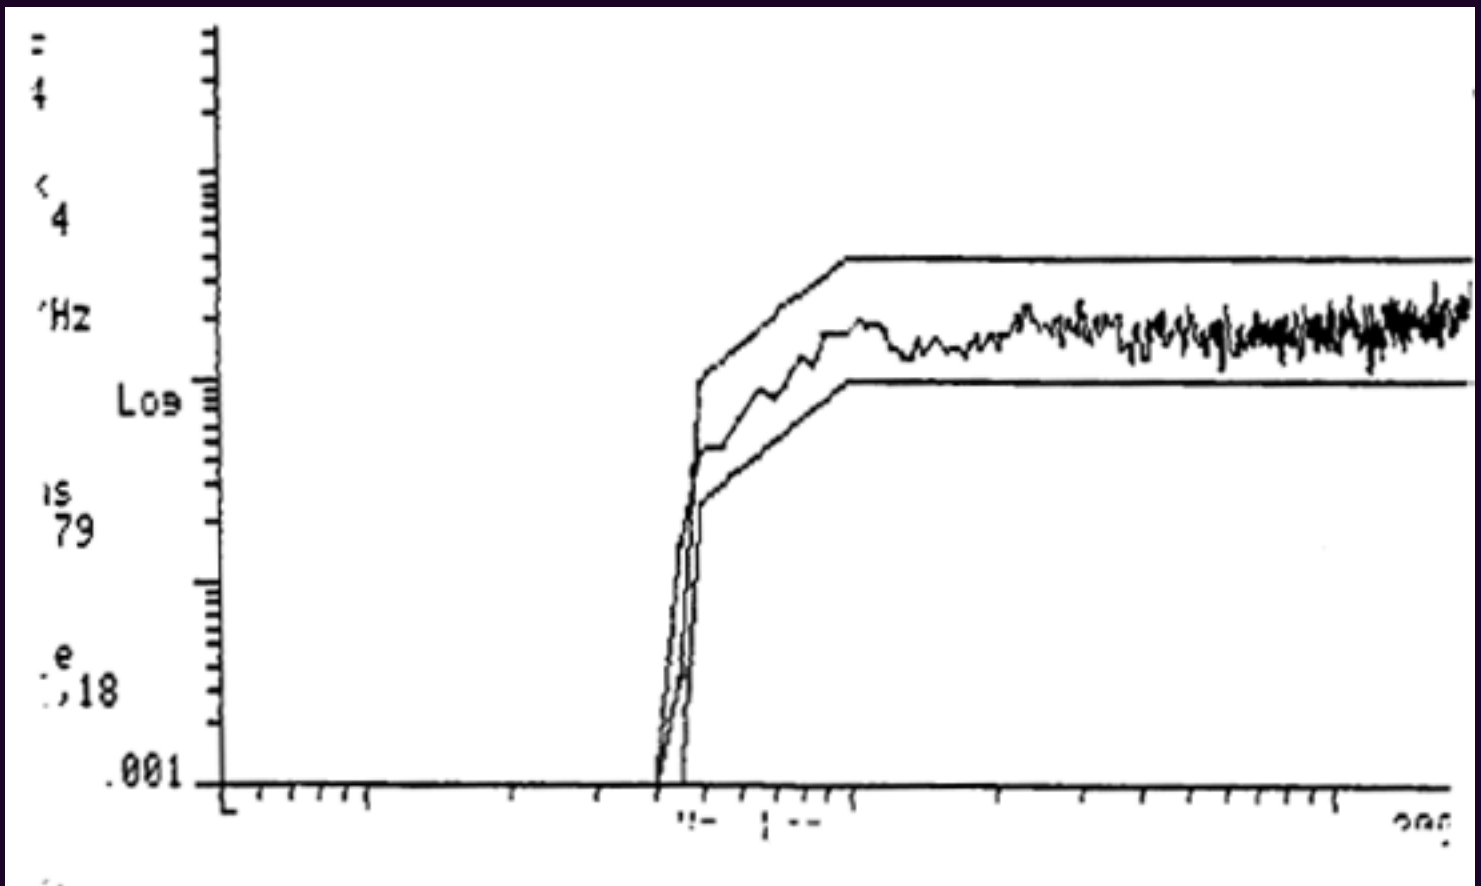
**Figure 10. Brackets Used for First and Second Vibration Tests**

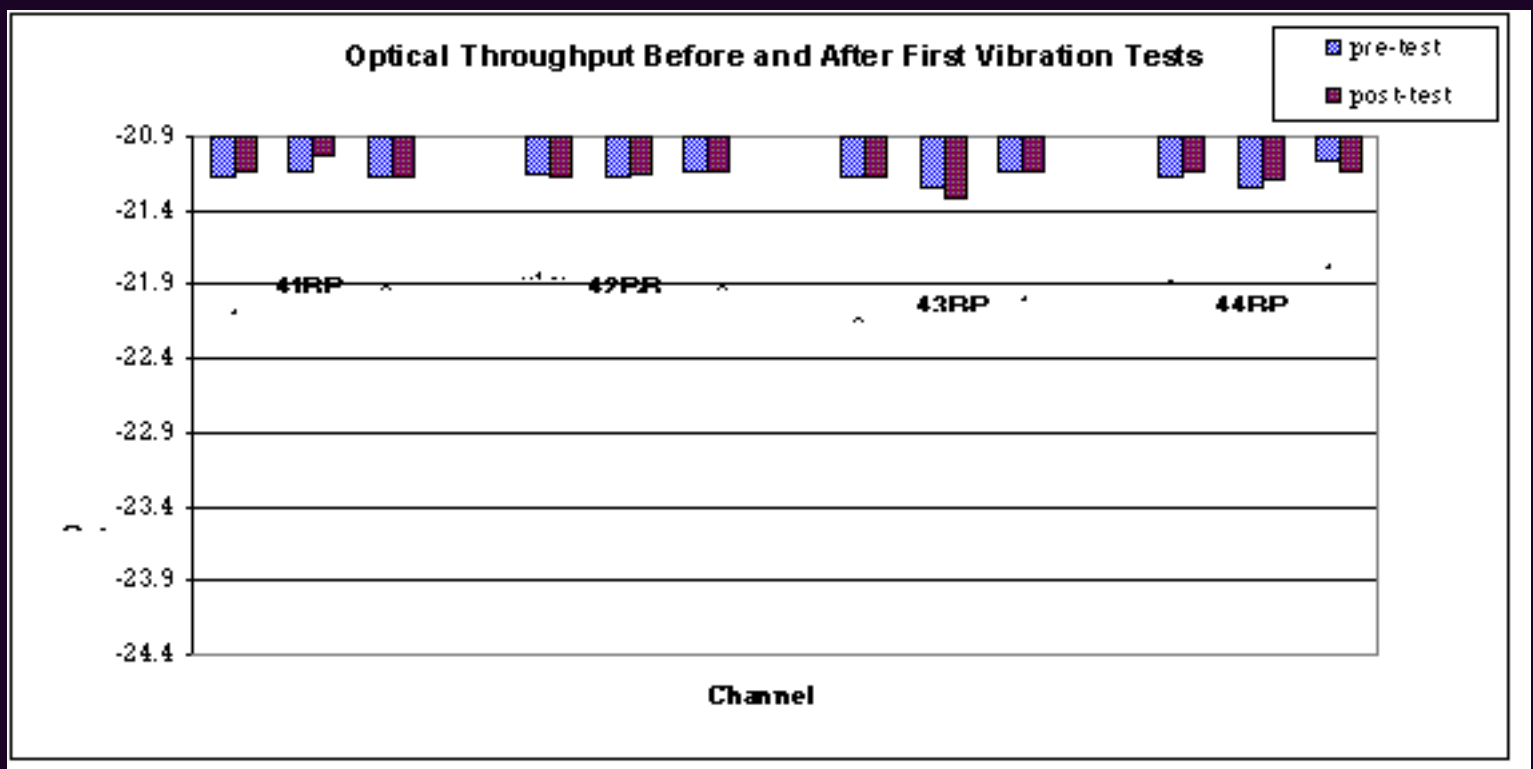
The second part of the vibration test was designed to determine whether the SMA connector ferrules would crush the active device lenses during vibration. The test results showed that the SMA connector ferrules did not affect the active device lenses and that no significant change occurred in throughput for the test cable. Figures 14 and 15 show that one of the two active devices subjected to the mated condition, did exhibit evidence of scratches on the metal package, but not on the glass.

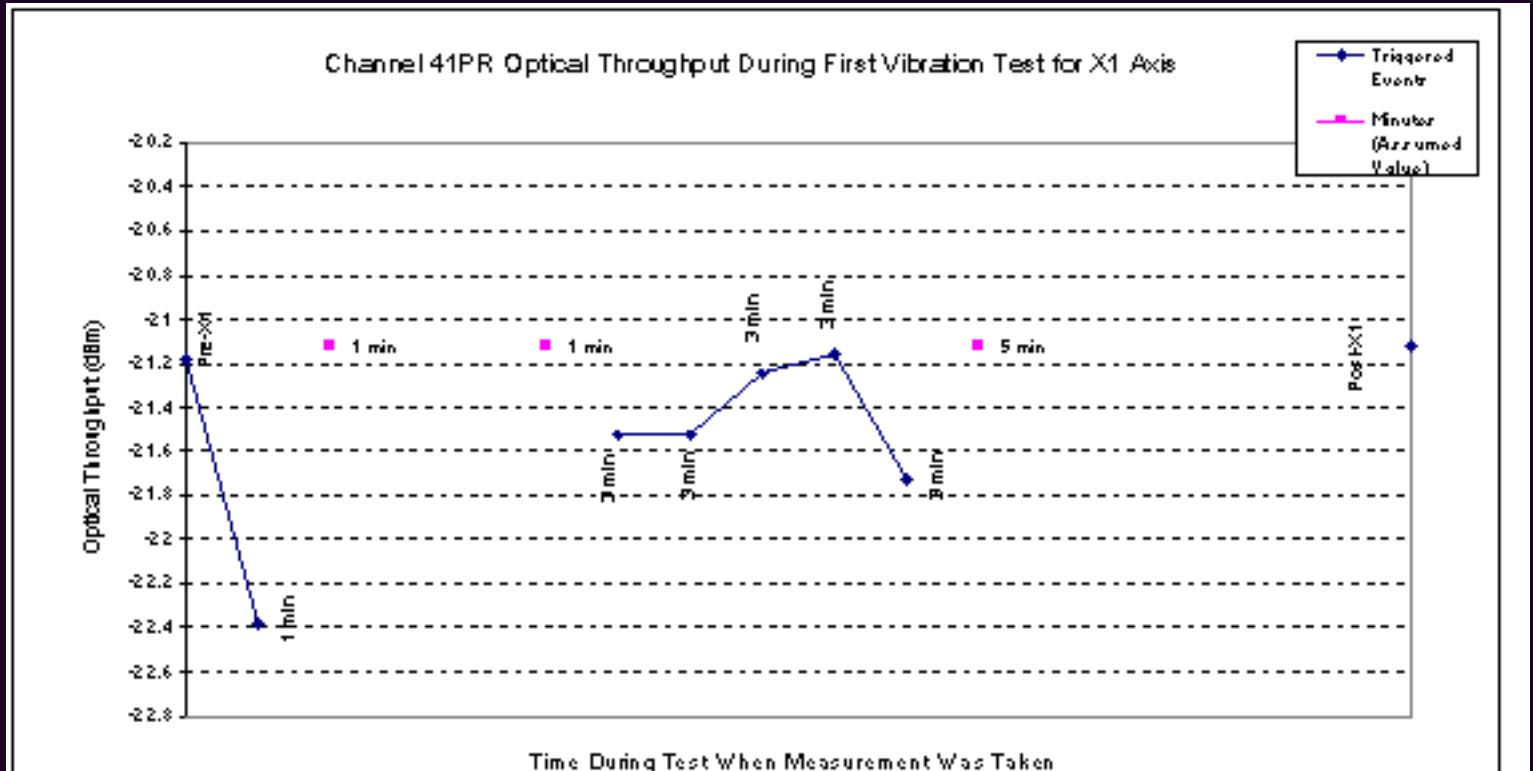
**Figure 15. Transmitter B After Vibration Test**

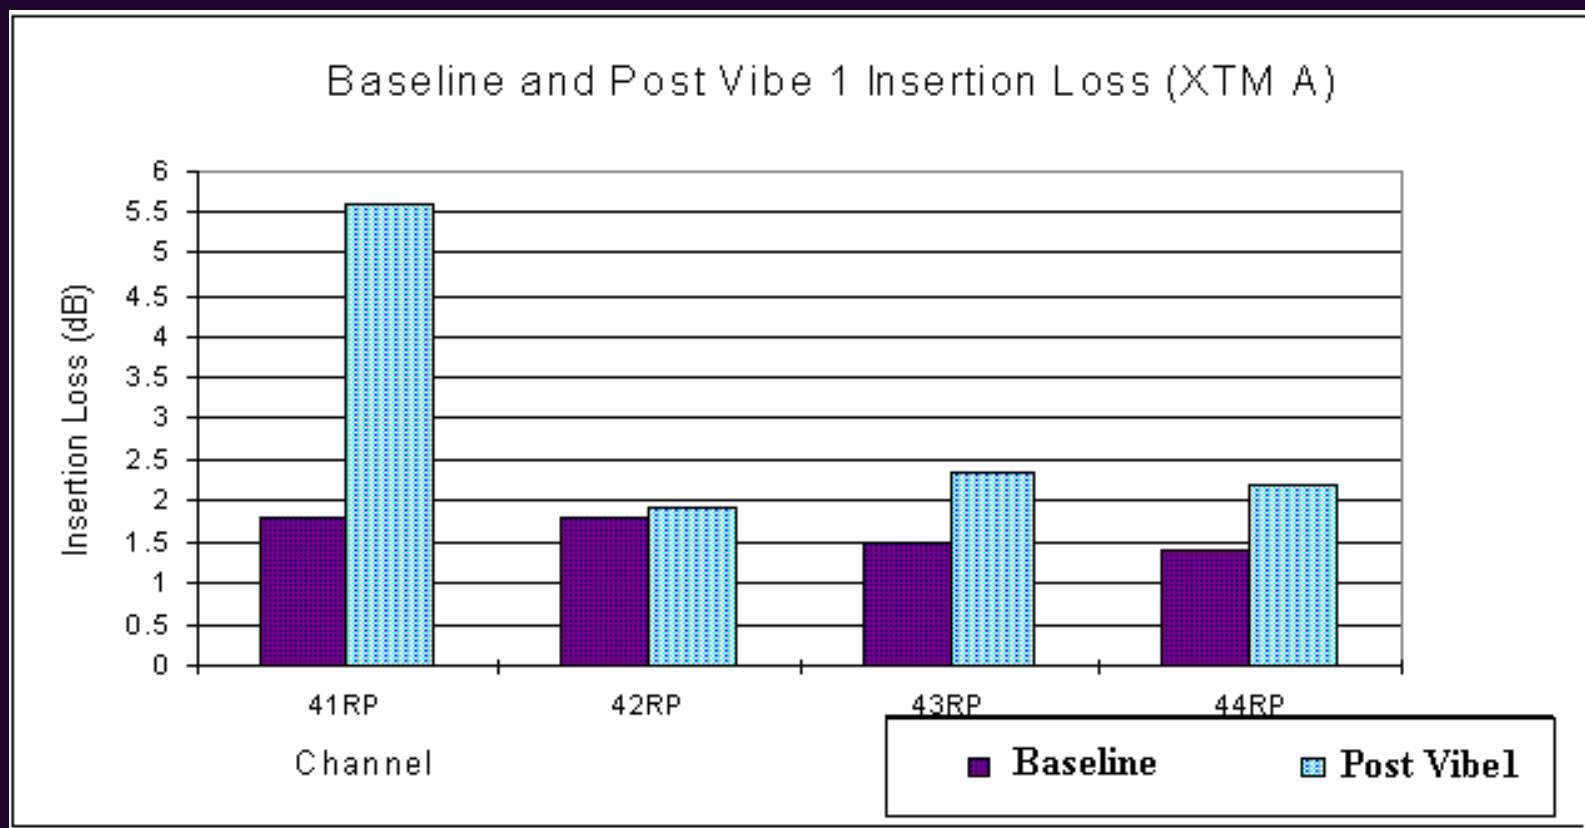
Although channels 42 through 44 showed a change in insertion loss between 0.1 and 0.8 dB, they stayed well below the manufacturer's ratings of 3.5 dB maximum. A review of the data indicates that the insertion loss for channels 43 and 44 increased after thermal cycling by about 0.2 dB which may correspond to the overall increase in surface features noted at that time. The factors noted above such as repeatability, handling and changes in radial alignment between the terminus pairs may account for an additional portion of the 0.8 dB increase in insertion loss. It is interesting to note that even though the fiber end faces for both the pin and socket for channel 42 saw significant increase in surface features over the duration of the test, channel 42's optical

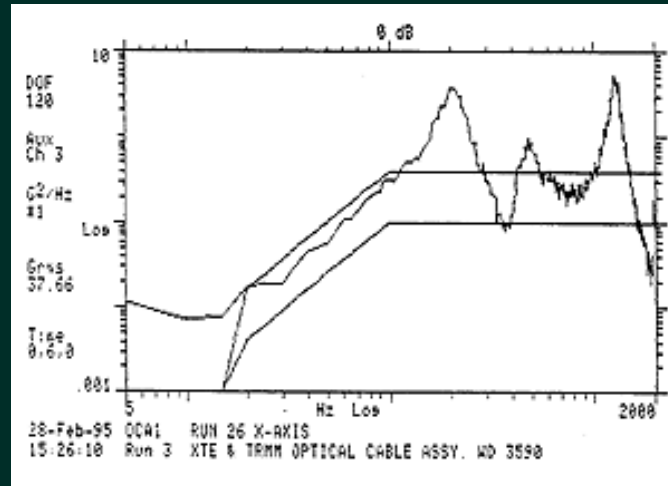
No trigger events were found during the first five runs (X1, X2, Y1, Y2, Z1). During the last z-axis test (Z2), several trigger events (momentary loss in excess of 0.5 dB) occurred for channel 43 during the first minute of the six minute test. Data for the second vibration test is provide in appendix A. No backing-off from the connector or backshell was noted and there was no disruption to the torque stripping.

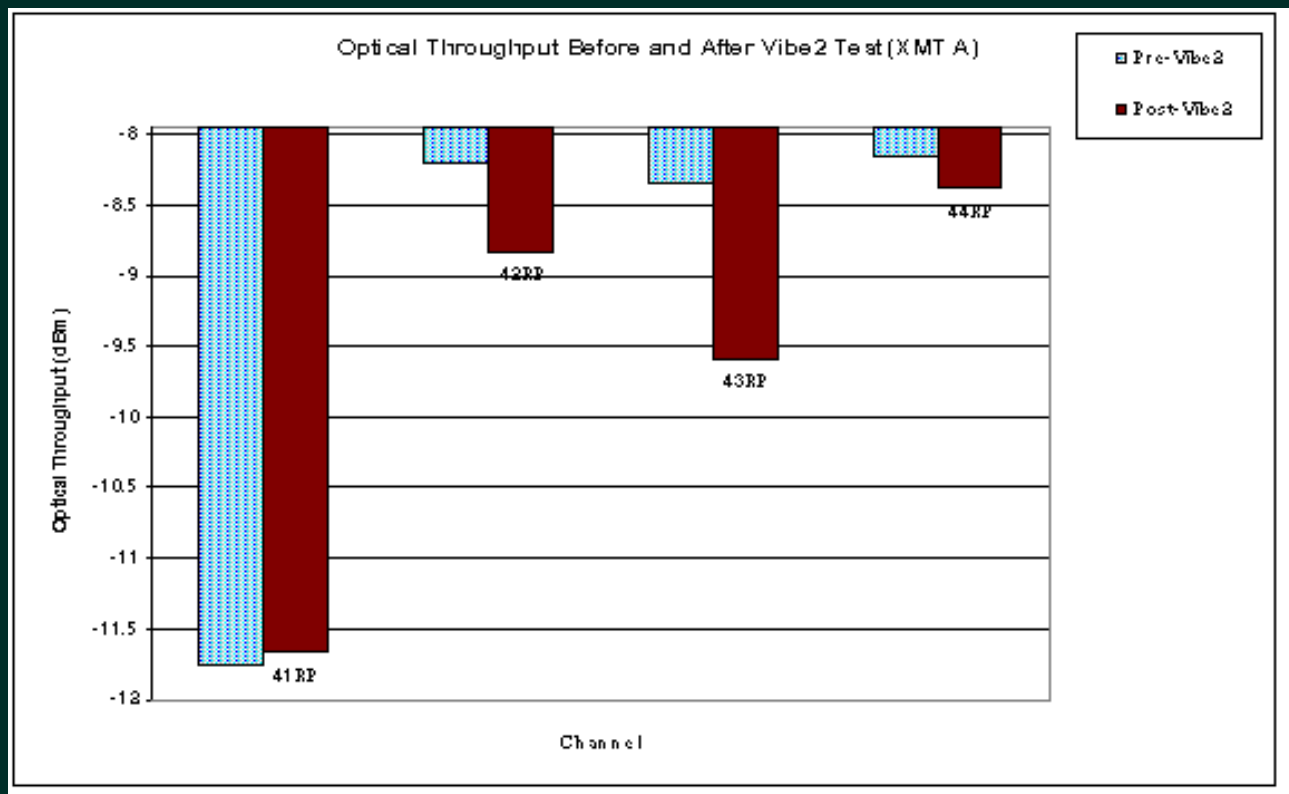
### 5.5.1 Visual Examination Following the Second Vibration Test
